Manhole Inspection Summary

Manhole # S37S__014MH

Insp Date: **2/25/08 9:07 AM**

Location Address: **1248 williams st**

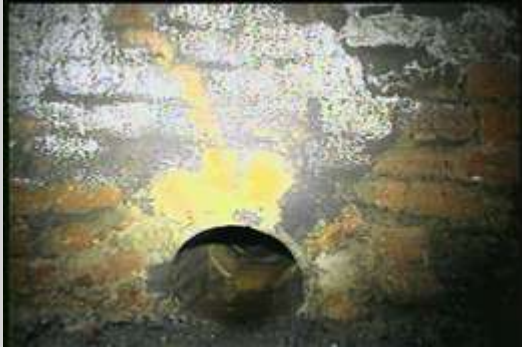
12 O'Clock Outflow

8 in. Circular Gravity Sewer
Pipe Out @ 12 O'Clock

Pipe Material: **Clay** ☐ Pipe Lined

Infiltration: **None** Pipe Seal Cond: **Unknown**
